TECHNICAL REPORT 3439
TEST OF 1/10 SCALE BAY STRUCTURE
REPORT NO. 6
ESTABLISHMENT
OF
SAFETY DESIGN CRITERIA
FOR USE IN
ENGINEERING
OF
EXPLOSIVE FACILITIES AND OPERATIONS

PICATINNY ARSENAL
DOVER, NEW JERSEY

JULY 1966

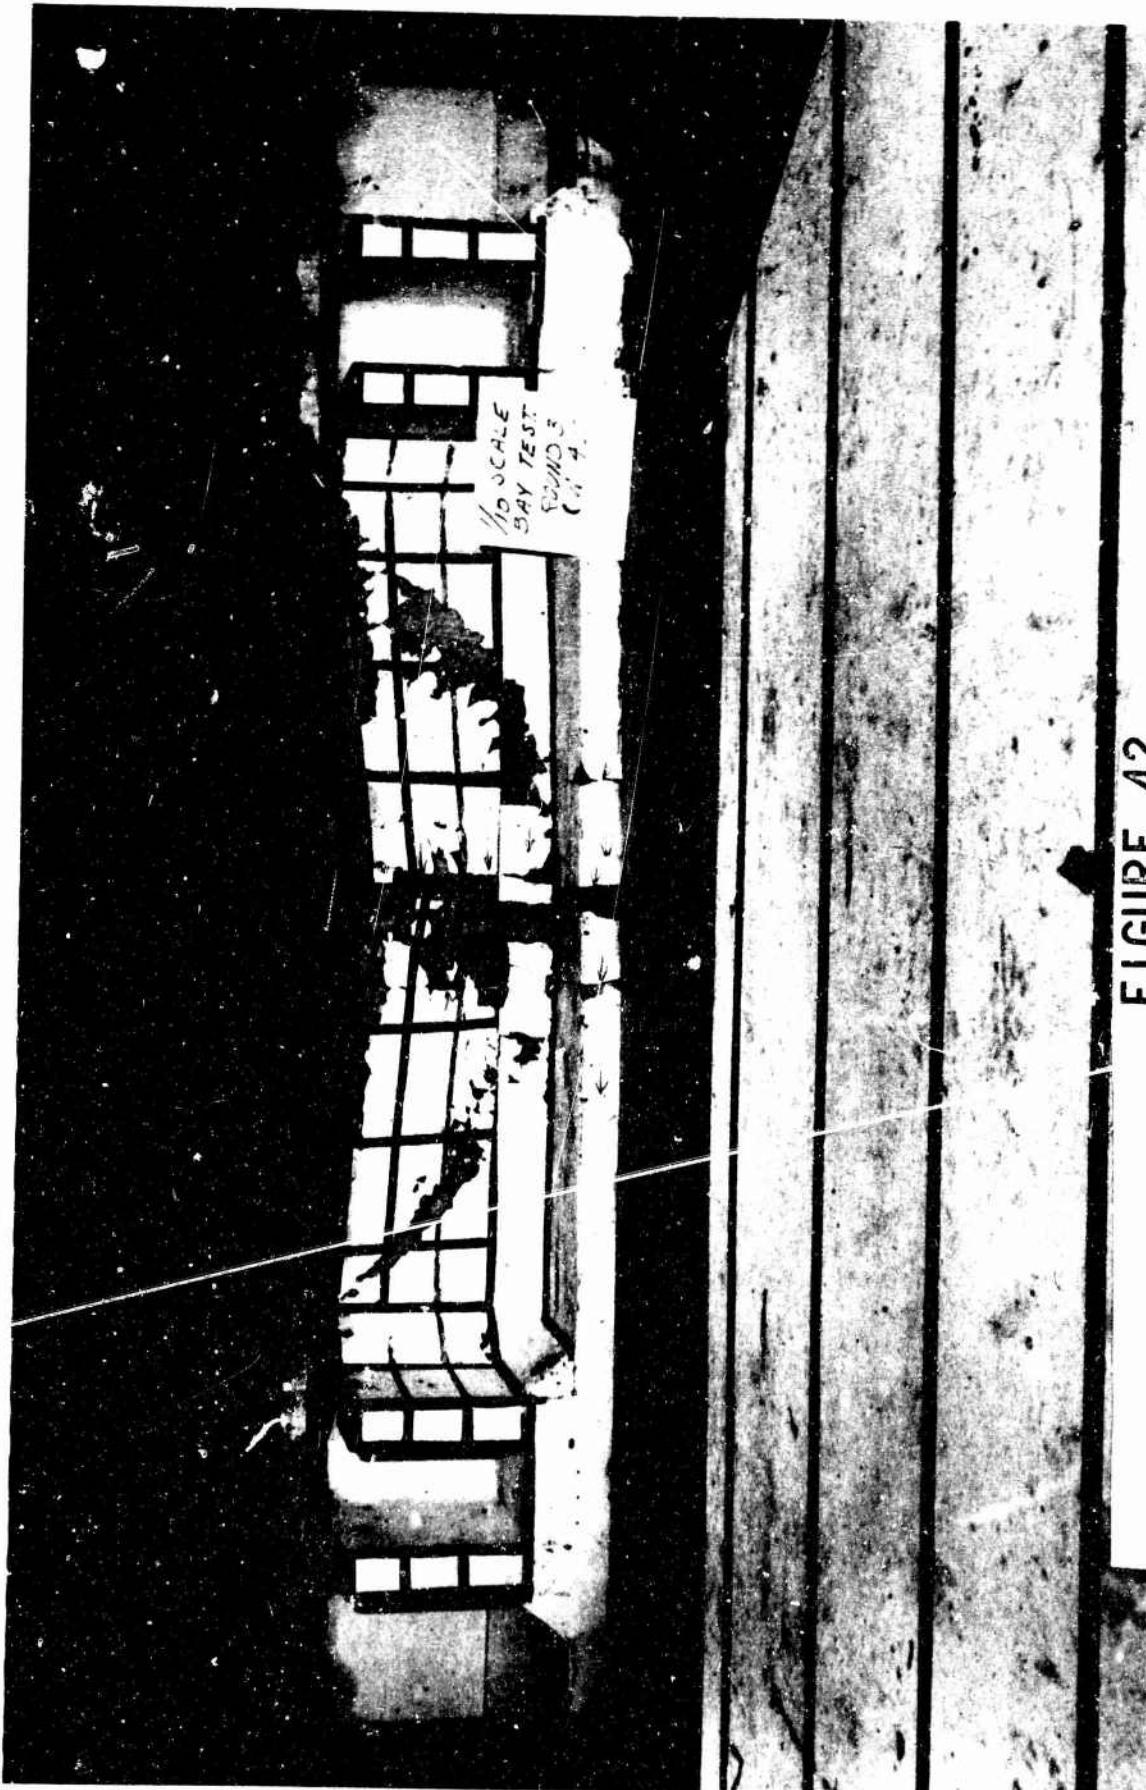
FIGURE 42
WALL 2 - DAMAGE TO ACCEPTOR PANEL - ROUND 3

The third test involved five centrally located Composition B charges totaling 4.25 lbs. The test resulted in extensive damage to the back wall (incipient failure). The final failure of the structure was caused by the increased load acting on the side wall which tended to split the structure in the middle, in addition to the damage sustained by the wall and the floor slab in two previous tests. The side walls remained basically intact except for slight failure at the intersections of the side and back walls in the donor panel.

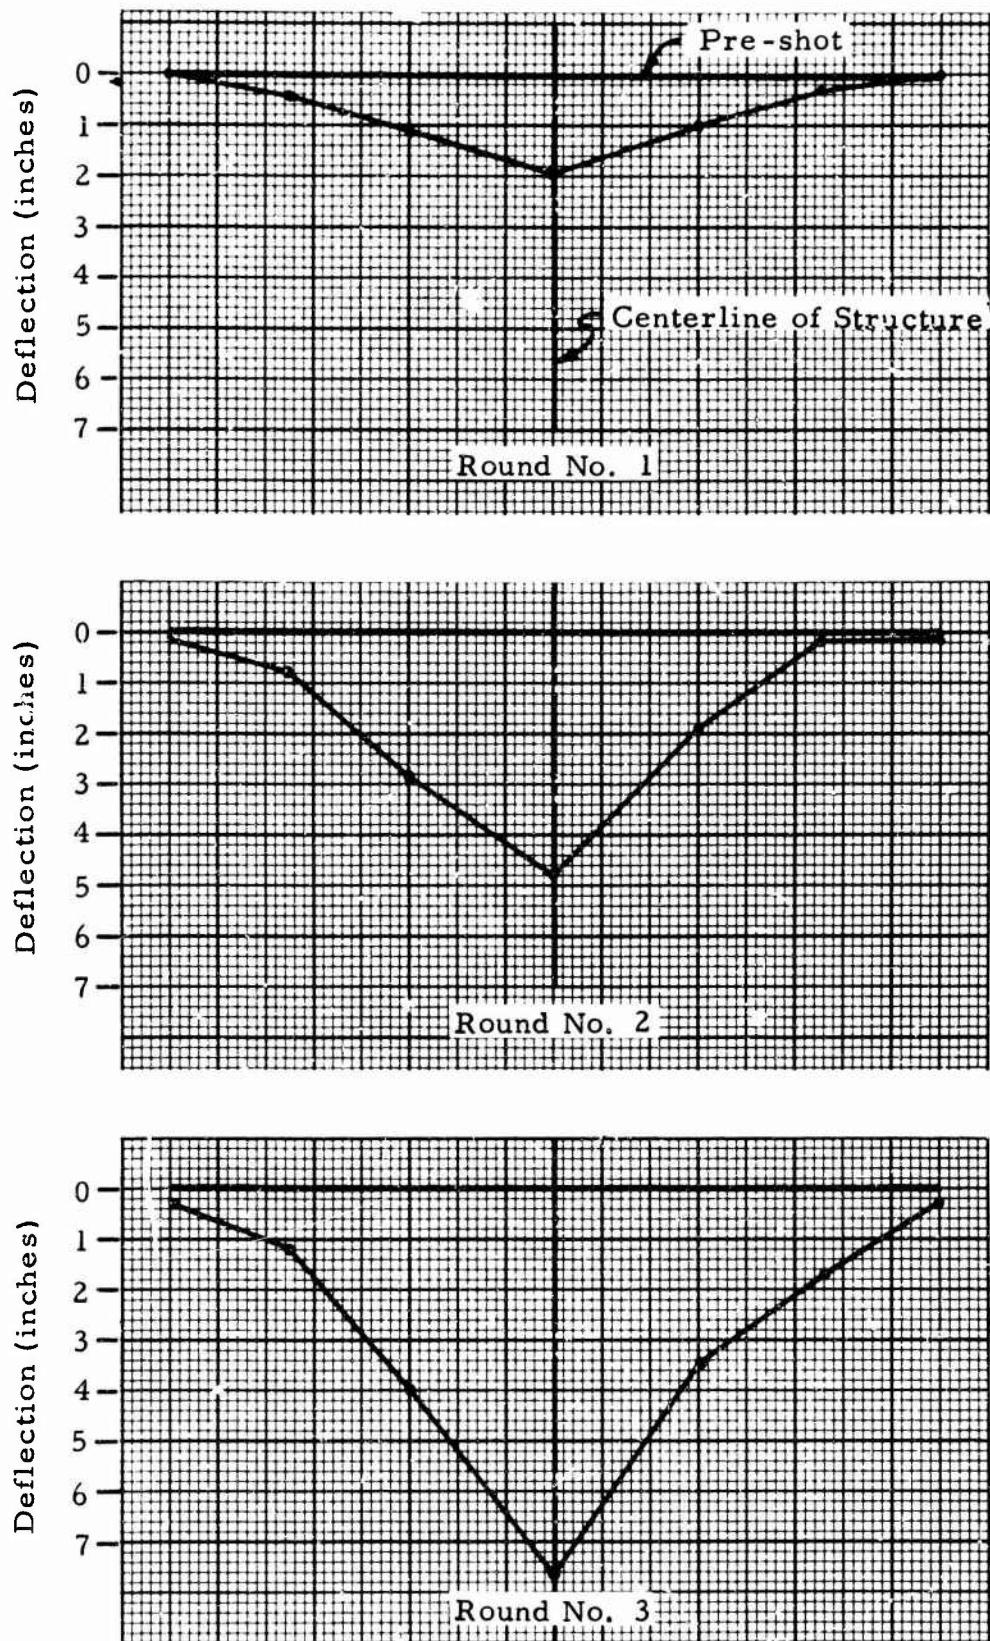
FIGURE 44
FLOOR SLAB -- PERMANENT DEFLECTIONS
MEASURED ALONG LONGITUDINAL CENTER
LINE

Figure 44 is a plot of the permanent deflections recorded along the longitudinal center line of the floor slab. Plotted in Figure 45 are the permanent deflections measured along the top of the donor and acceptor panels of the back wall. Relative donor panel deflections of the side walls are plotted in Figure 46. Contours of all recorded deflections are indicated in the various views of Figures 47-49.

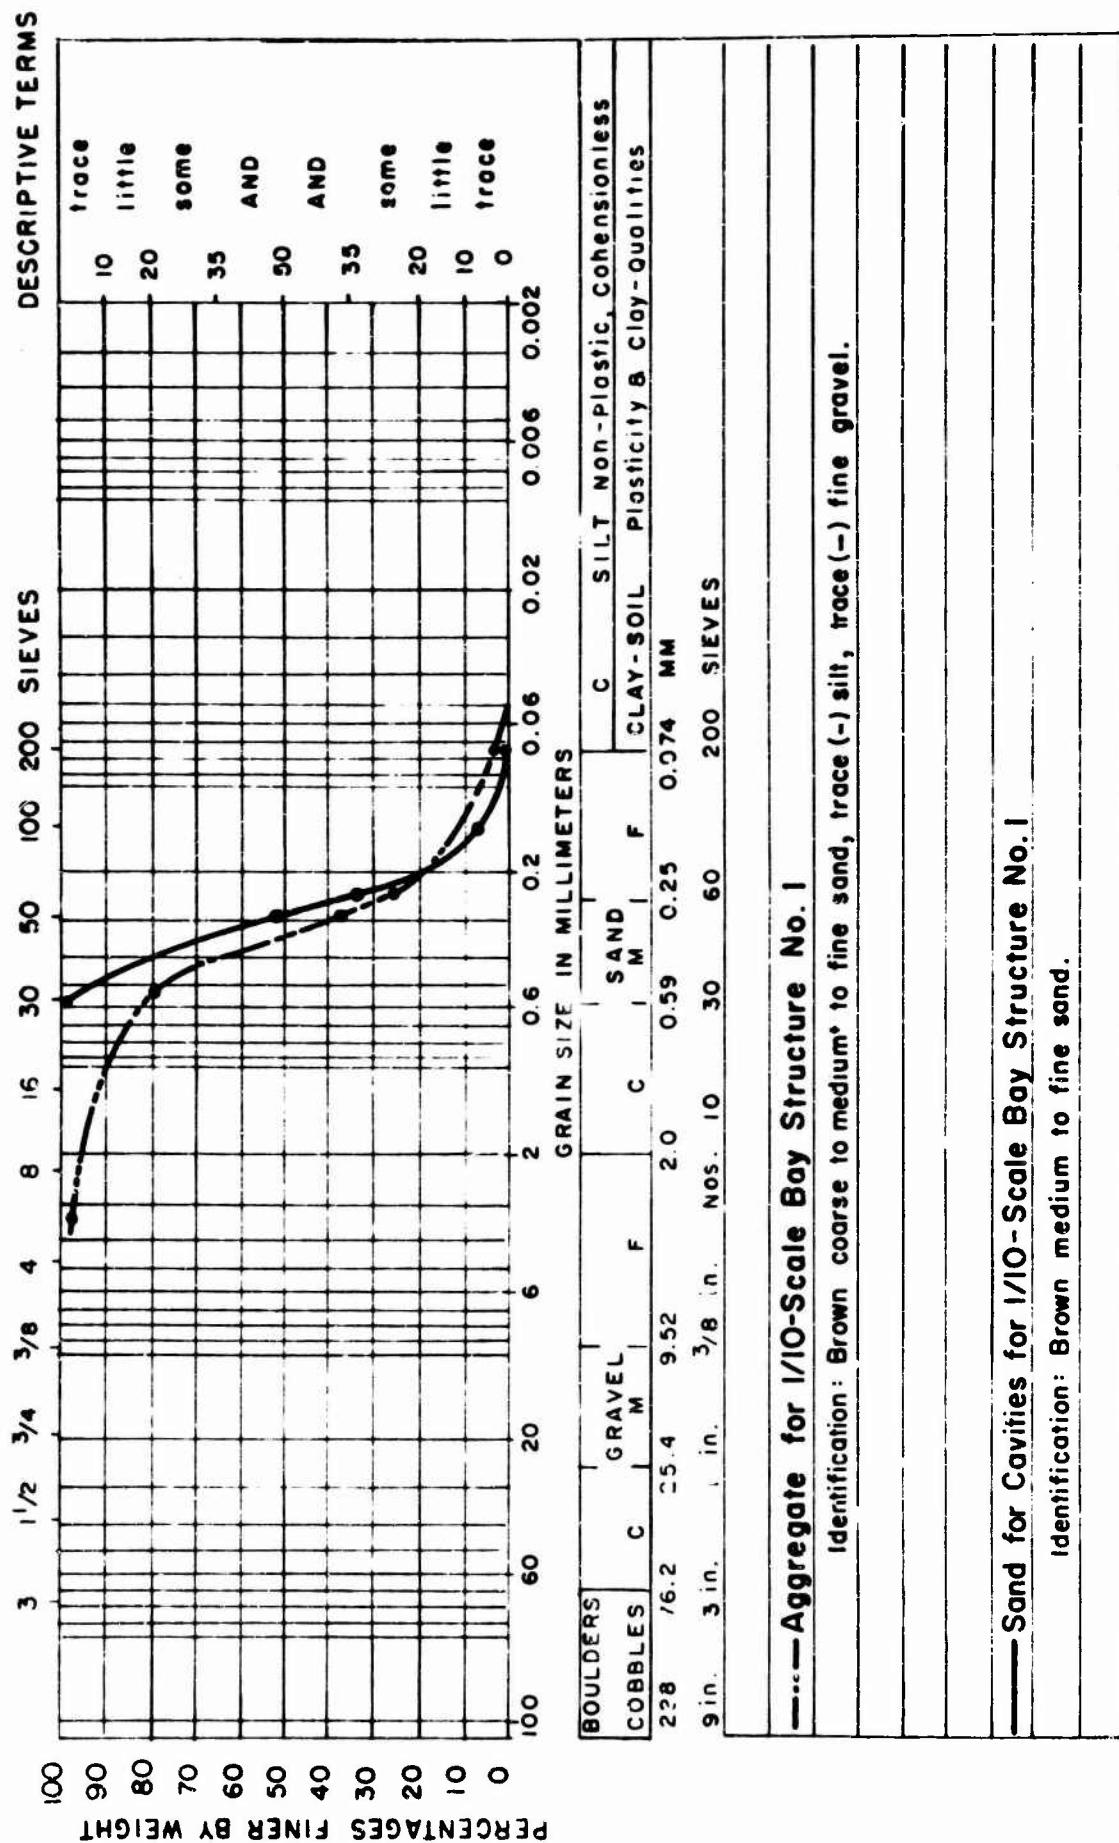
FIGURE A-1
GRAIN SIZE ANALYSIS: AGGREGATE AND SAND FOR CAVITIES

Sand (for Wall Cavities) -- Tested according to ASTM Standard D422-63. Material is sand, medium to fine, grain sizes ranging from 0.6mm through 0.06mm (Figure A-1).

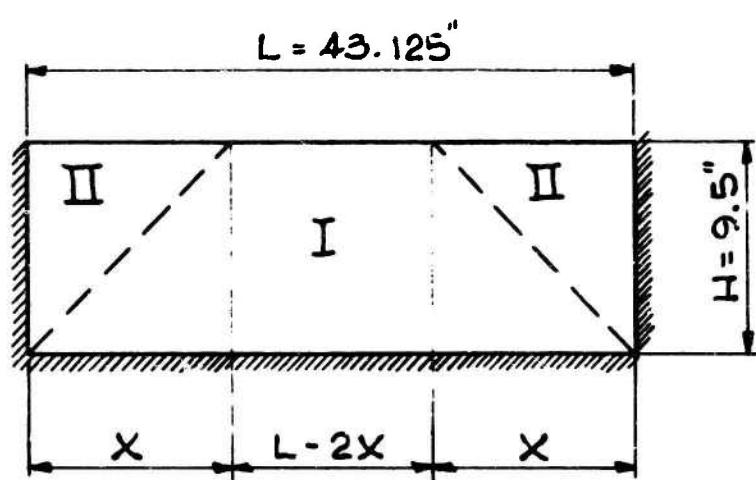
Each panel of the back wall is considered as a plate fixed on three adjoining sides and free on the fourth side (Figure B-2).

FIGURE B-2
ELEVATION OF BACK WALL SHOWING
CRACK PATTERN

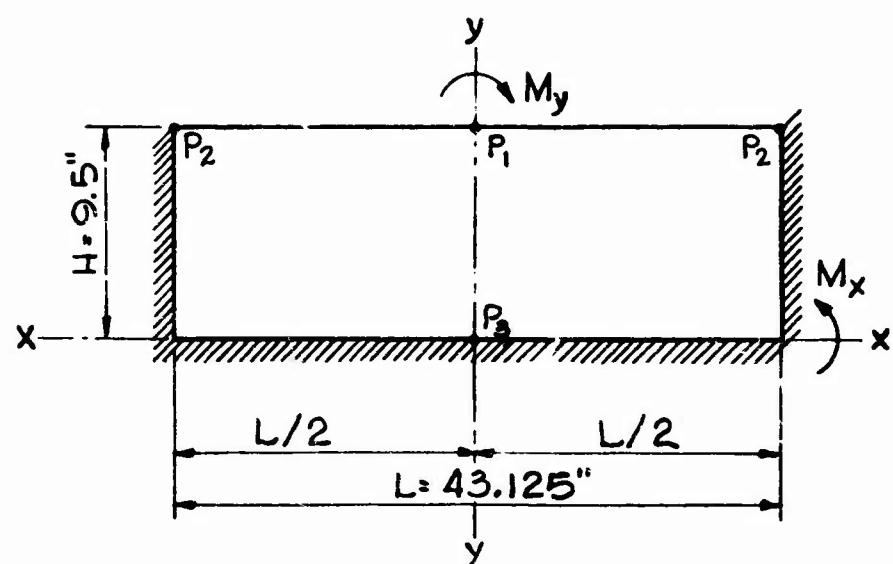
FIGURE B-11

NOTE: Because $r(P_2) < r(P_3)$ the reinforcement will yield at location 2 first. Therefore, the panel will then assume simple-simple-fixed-free support conditions.

ELEVATION OF WALL PANEL SHOWING LOCATION
OF CRITICAL POINTS IN ULTIMATE BENDING
FAILURE
